INTERMEDIATE AIR RECEIVER FRACTURE

An apparently standard air vessel burst and tore from its mounting. This case describes circumstances of use of this pressure vessel, and some investigations on the possible causes of failure.

INTERMEDIATE AIR RECEIVER FRACTURE - PART A

An investigation into a potentially fatal accident, traced to its probable causes by the author, W. Ernst Eder, The University of Calgary.

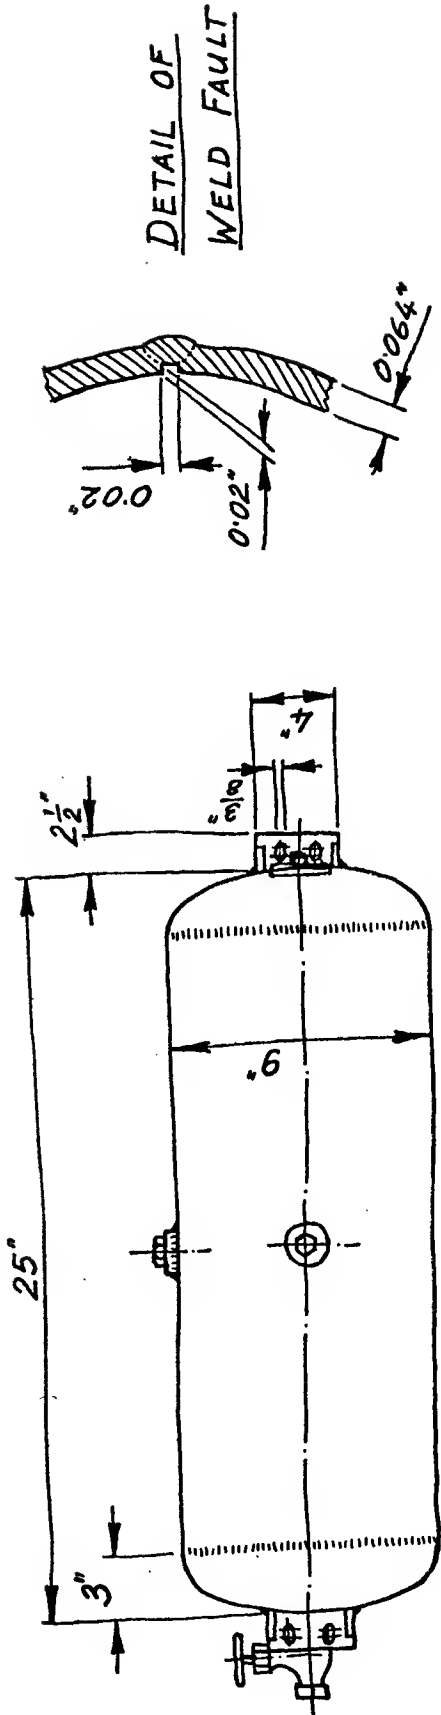
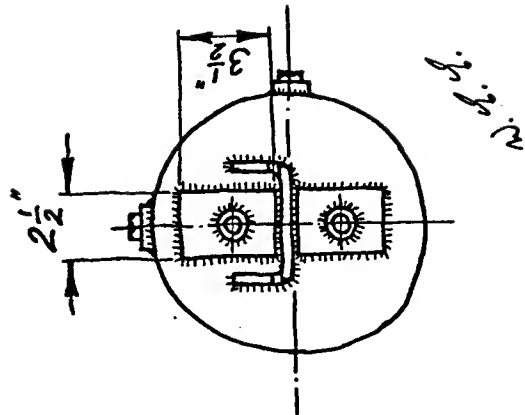
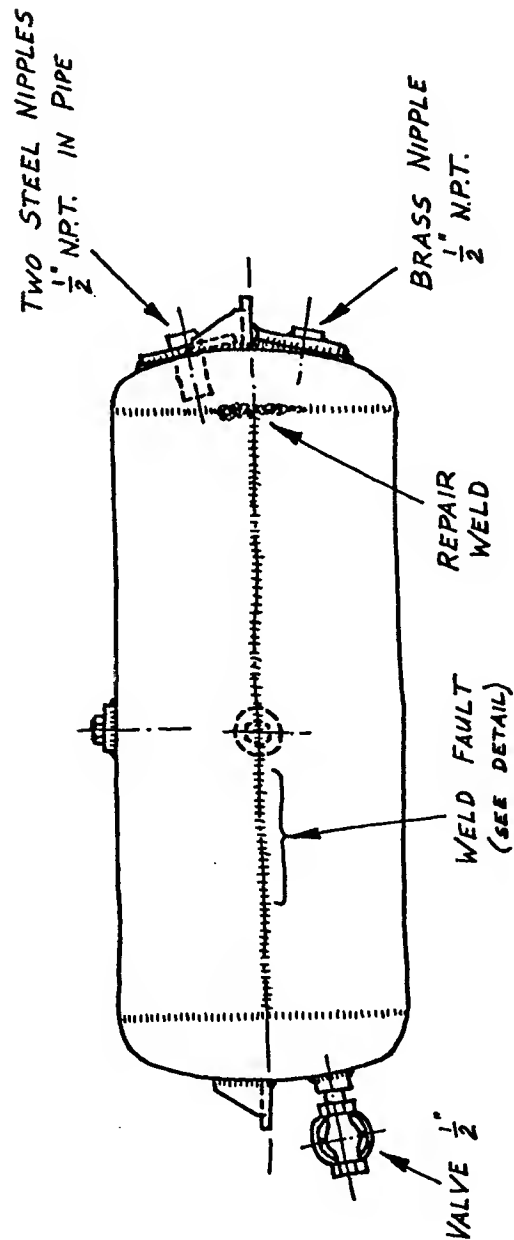
Exhibit 1 - INTERMEDIATE AIR RECEIVER, E.R.C.B. - DIMENSIONS

The opposite end of the receiver contained two entries (see figs. 13 and 14). One was a boss with a single brass screwed pipe end, which had fractured at the entry in the root of a male thread. The second was a tube entering the vessel, with two steel screwed pipe ends, one entering from inside the vessel, the other from outside, both showing fractures at the entry points. The areas around these entries had been reinforced by welded plates, the welds having been made by electric arc hand welding. Slag was not cleaned off, weld spatter appeared on the parent metal and on the reinforcements, and the corrosion protection paint on the inside surface of the vessel had been burned off. The head seams on the air receiver, close to the longitudinal seam of the body, had been repair-welded, leaving an unpainted area visible on the inside (see figs. 6 and 13).

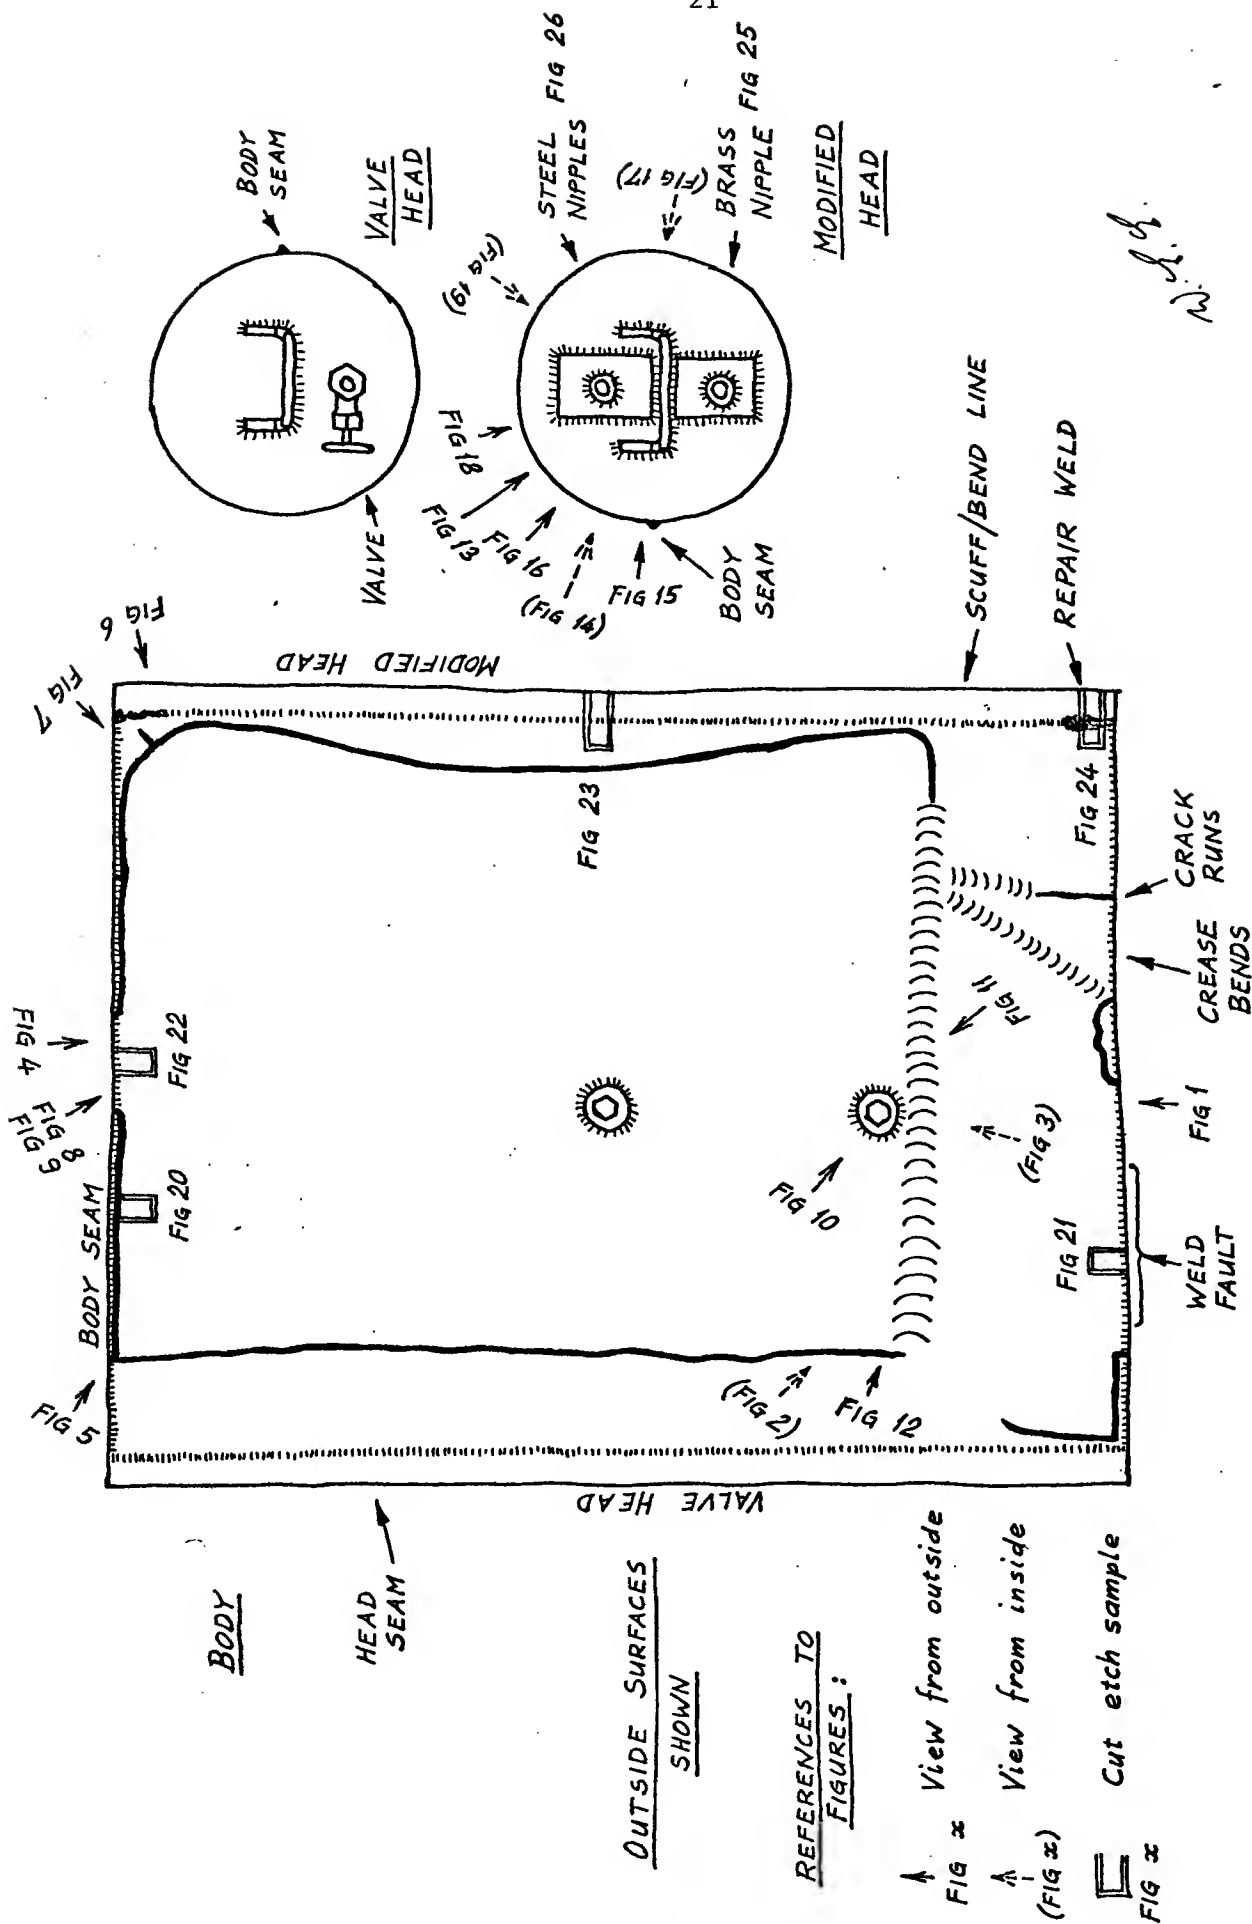
OUTSIDE SURFACES
SHOWN

Sample 1 (fig. 20) was taken from about the middle of the vessel, at the free edge of the rupture (see exhibit 3). It shows the 45° slope of the rupture surface and the thinning behind it. The grain structure under microscopic observation shows a distinct stretching of individual grains as the fracture surface is approached. Failure was in a shear mode, typical of a ductile fracture under relatively low rate of stress application, with little constraint by stress concentration effects.
